# Quality of Pond Sediments

**John E. Weinstein**

Biology Department

The Citadel

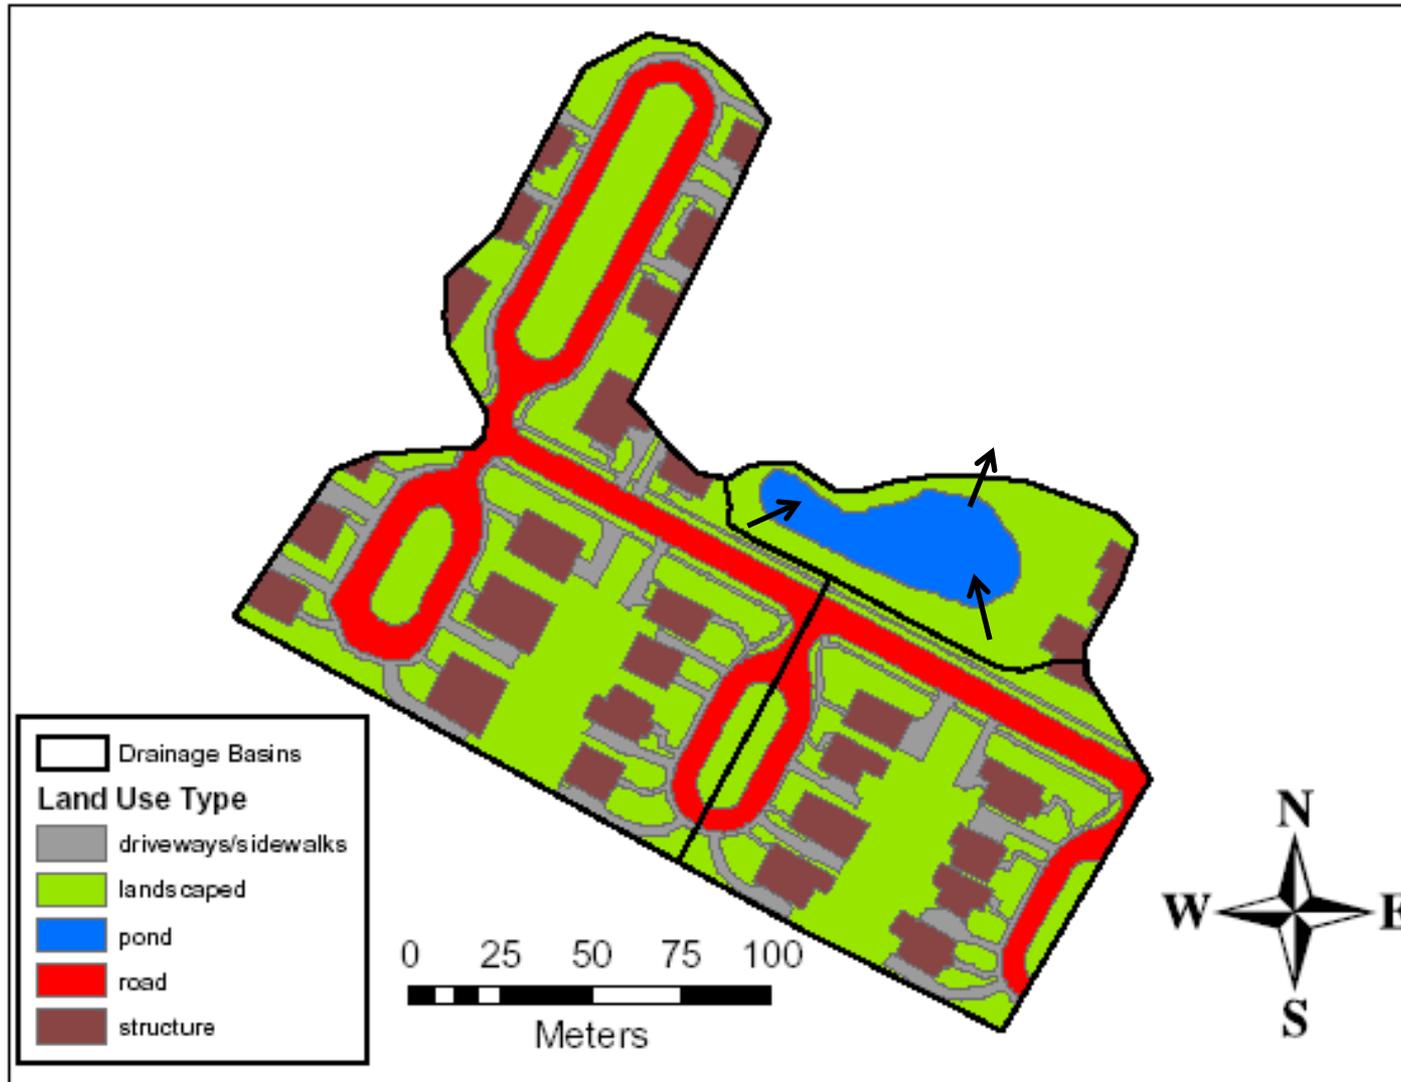
# Map depicting land cover in typical single residential pond, Daniel Island, SC

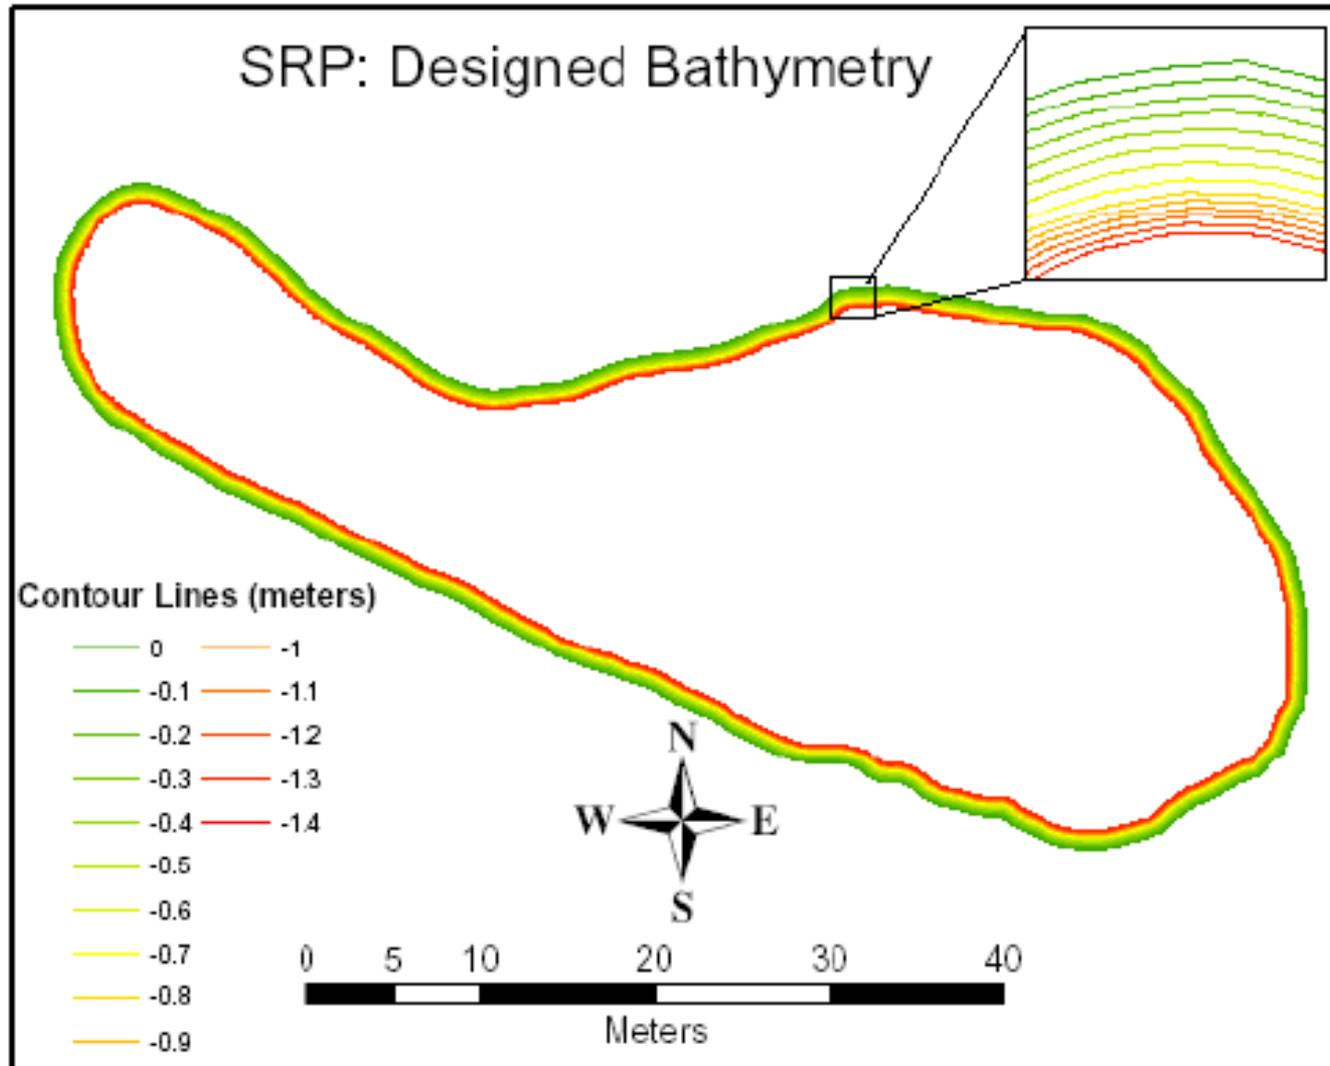
# Designed bathymetry of single residential pond by Thomas and Hutton Engineering (permitted 1999)

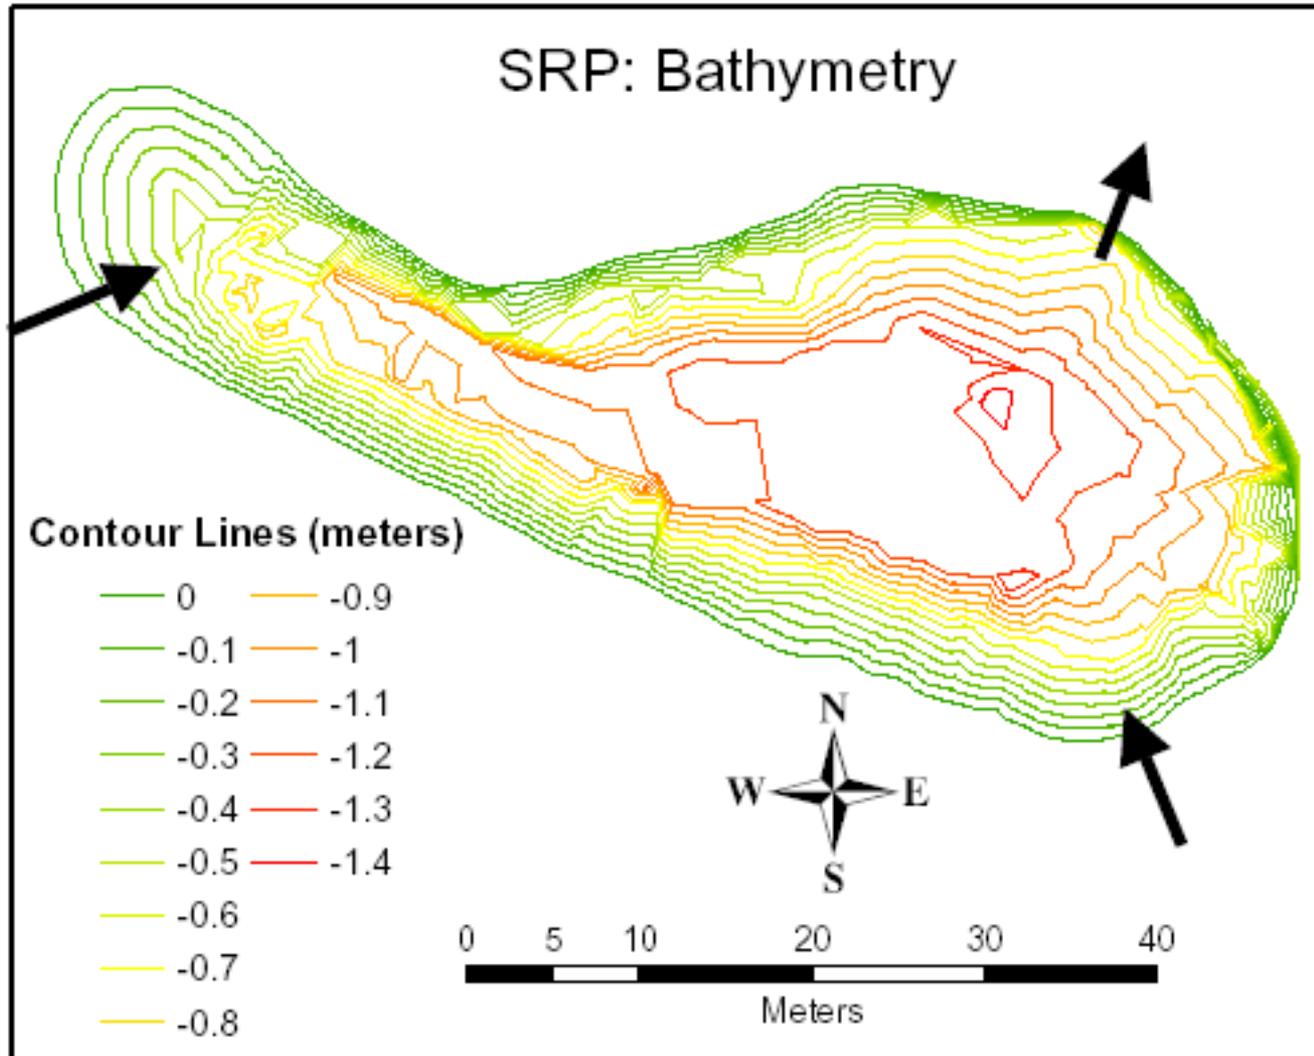
# Measured pond bathymetry of single residential pond (2006)

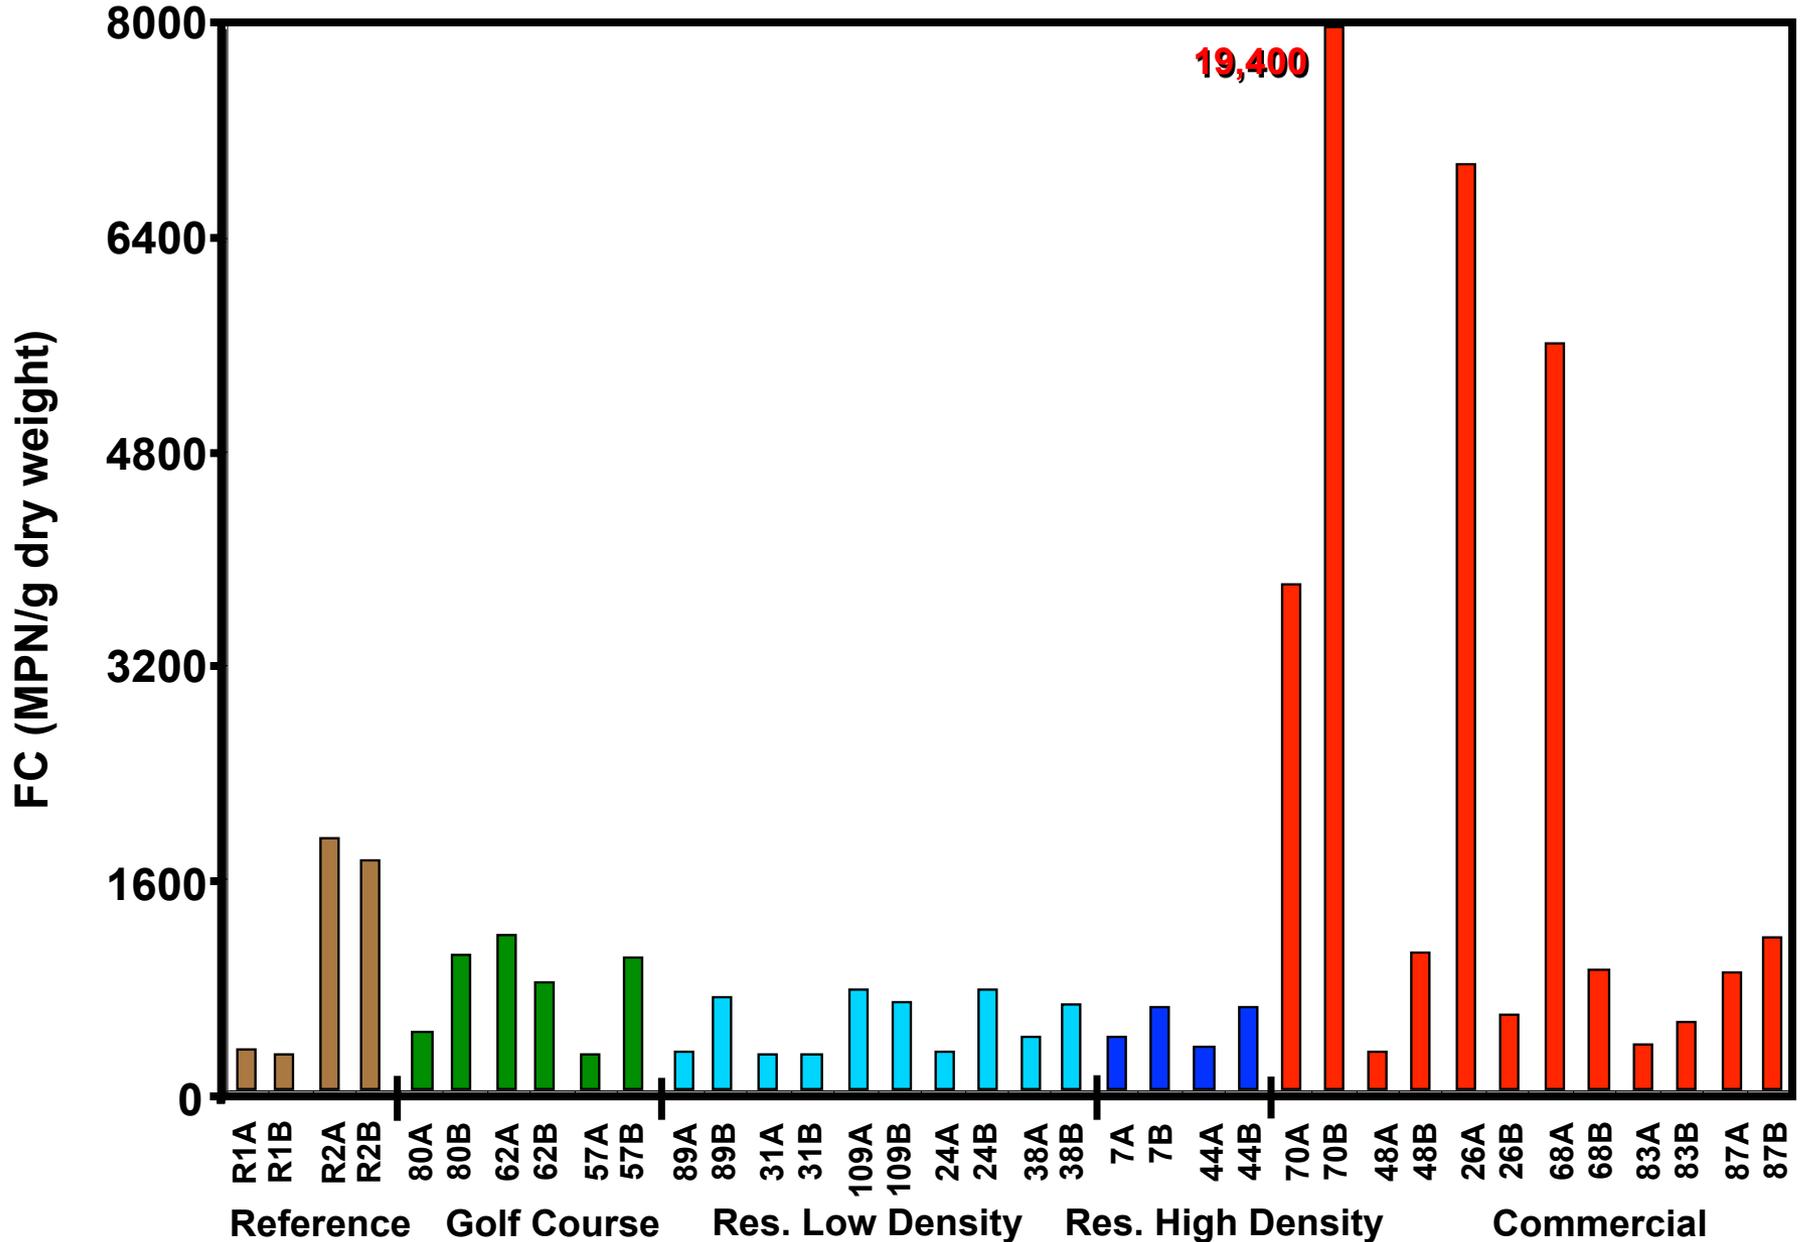
# Sediment Fecal Coliform

- Commonly used as an indicator of fecal contamination (human and animal)
- Fecal coliform levels were generally similar to reference pond sediments
